**DEPARTMENT OF TRANSPORTATION**

Office of Structural Materials

Contract #: 04-0120F4Cty: SF/ALA Rte: 80 PM: 13.2/13.9File #: 99.28**WELDING INSPECTION REPORT****Resident Engineer:**Siegenthaler, Peter**Address:** 333 Burma Road**City:** Oakland, CA 94607**Report No:** WIR-017192**Date Inspected:** 02-Oct-2010**Project Name:** SAS Superstructure**OSM Arrival Time:** 700**Prime Contractor:** American Bridge/Fluor Enterprises, a JV**OSM Departure Time:** 1900**Contractor:** Zhenhua Port Machinery Company, Ltd (ZPMC) Chanxing Island**Location:** Shanghai, China**CWI Name:** Mrs. Lv Yun**CWI Present:** Yes No**Inspected CWI report:** Yes No N/A**Rod Oven in Use:** Yes No N/A**Electrode to specification:** Yes No N/A**Weld Procedures Followed:** Yes No N/A**Qualified Welders:** Yes No N/A**Verified Joint Fit-up:** Yes No N/A**Approved Drawings:** Yes No N/A**Approved WPS:** Yes No N/A**Delayed / Cancelled:** Yes No N/A**Bridge No:** 34-0006**Component:** OBG Segment**Summary of Items Observed:**

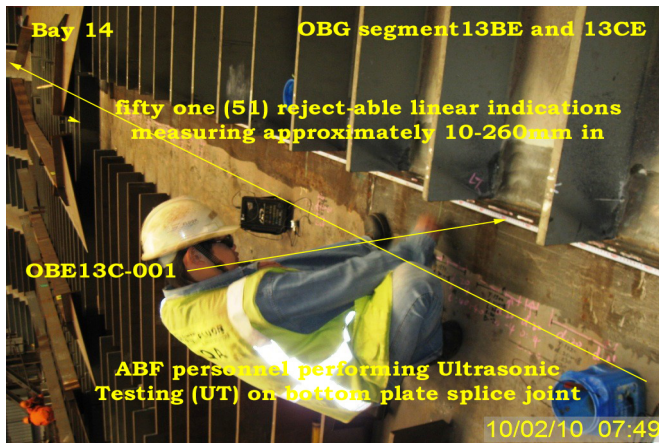
bottom plate splice joint joining between Segments 13BE to 13CE. ABF UT personnel found fifty one (51) reject-able linear indications measuring approximately 10-260mm in lengths. The weld is identified as OBE13C-001. The Weld is Complete Joint Penetration (CJP) transition butt joint. The Weld is Seismic Performance Critical Members (SPCM). The Thickness of the bottom plates are {25/30}, {35/22} and {25/16}. The bottom plates are located at bay #14. The indications are clearly marked by ABF UT Technician on/near the weld. The problem occurred; because of ZPMC not performed back gouging and SAW or SMAW welding. See the attached picture and the indication details are as follows:

The ratings are -2db to +8dB and length approximately 10 to 260mm.

The depth (d) approximately measured 16 to 20mm

The X-values approximately measured 20 to 25mm

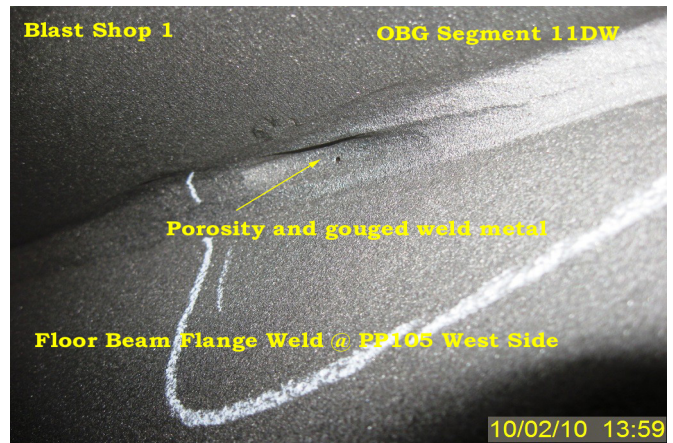
Segment 11DW

This QA Inspector performed a preliminary random visual inspection on OBG Segment 11DW, after the grit blast of the interior components of the deck panel, floor beams and corner assemblies of this segment. Areas of visual weld defects that will require welding were taped and will be repaired after the coating is applied. ZPMC QC personnel are aware of these areas and were present during the inspection. See the attached file.
